# U P D A T E

A PERIODICAL FOR THE HOMEOWNER

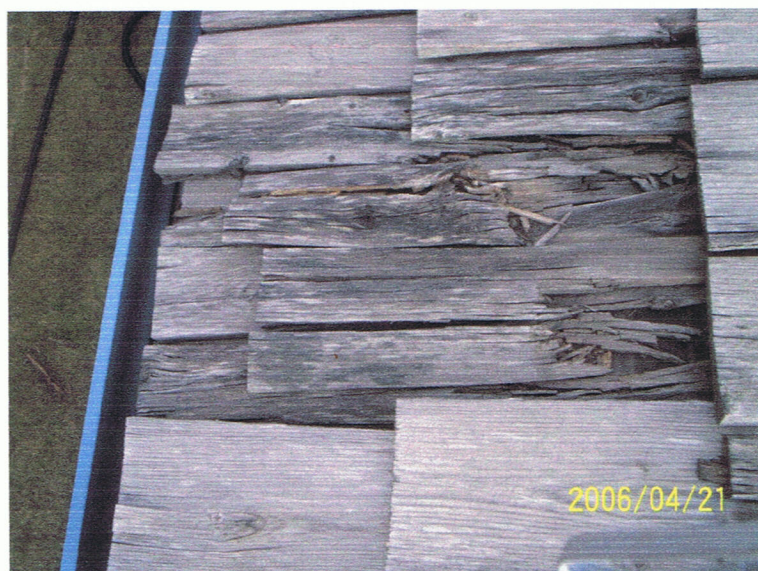
Typically in the Edmonton area the life expectancy of untreated pine shakes is any where from 8 to 12 years. Most untreated roof covers at 12 years are showing extensive decay and deterioration.

In some cases only the underlayment is left to protect the house from water penetration. Complete replacement is the only solution.

Whenever you see the usual silver colour of the ageing pine turn to a black colour, the black shakes are likely being attacked by an airborne fungus. As the micro organism migrates to the damper areas of the shake as the surface dries out, the rot is usually hard to spot without careful observation. The damper spots are generally underneath the shake, and by the time you see the dry checkered rot on the surface, it may be more serious than first thought. Pine shake manufacturers in Alberta became aware of an airborne fungus causing pine shake rot in 1997. Most companies quit making them, and have only sold treated pine shakes since.
